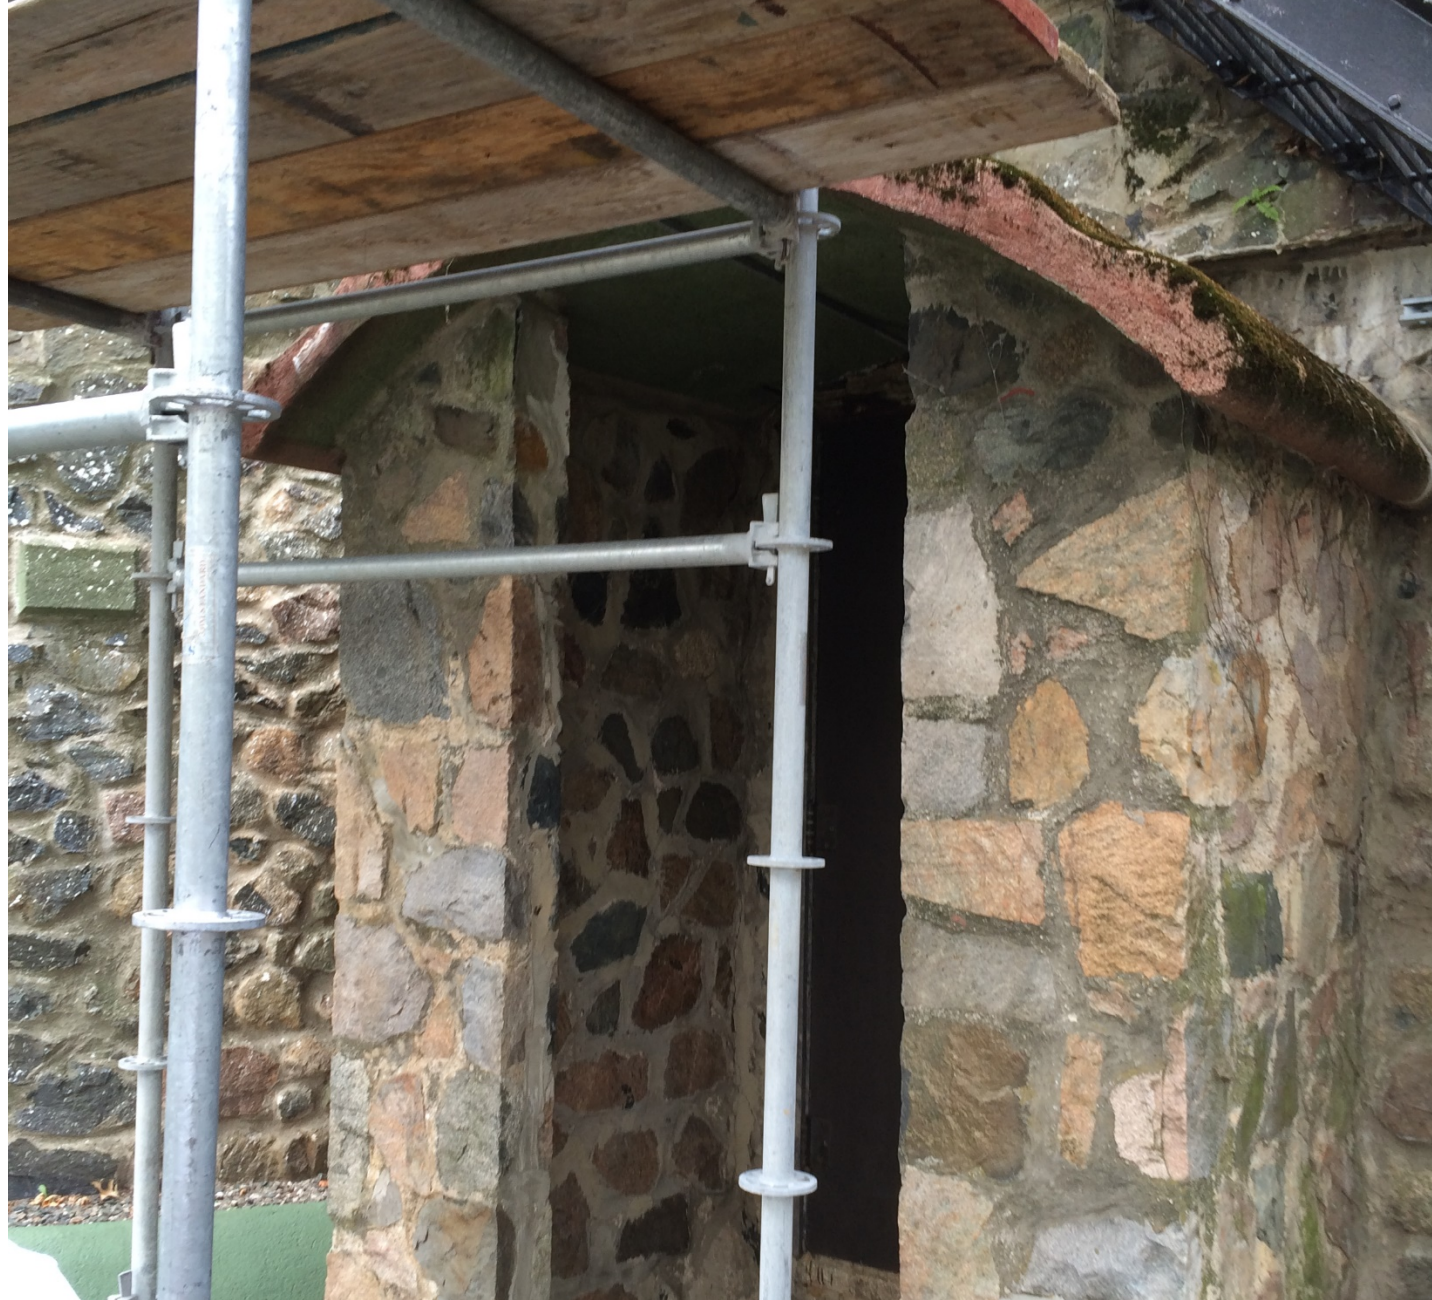
**View of protective scaffolding
at Tower C entry**

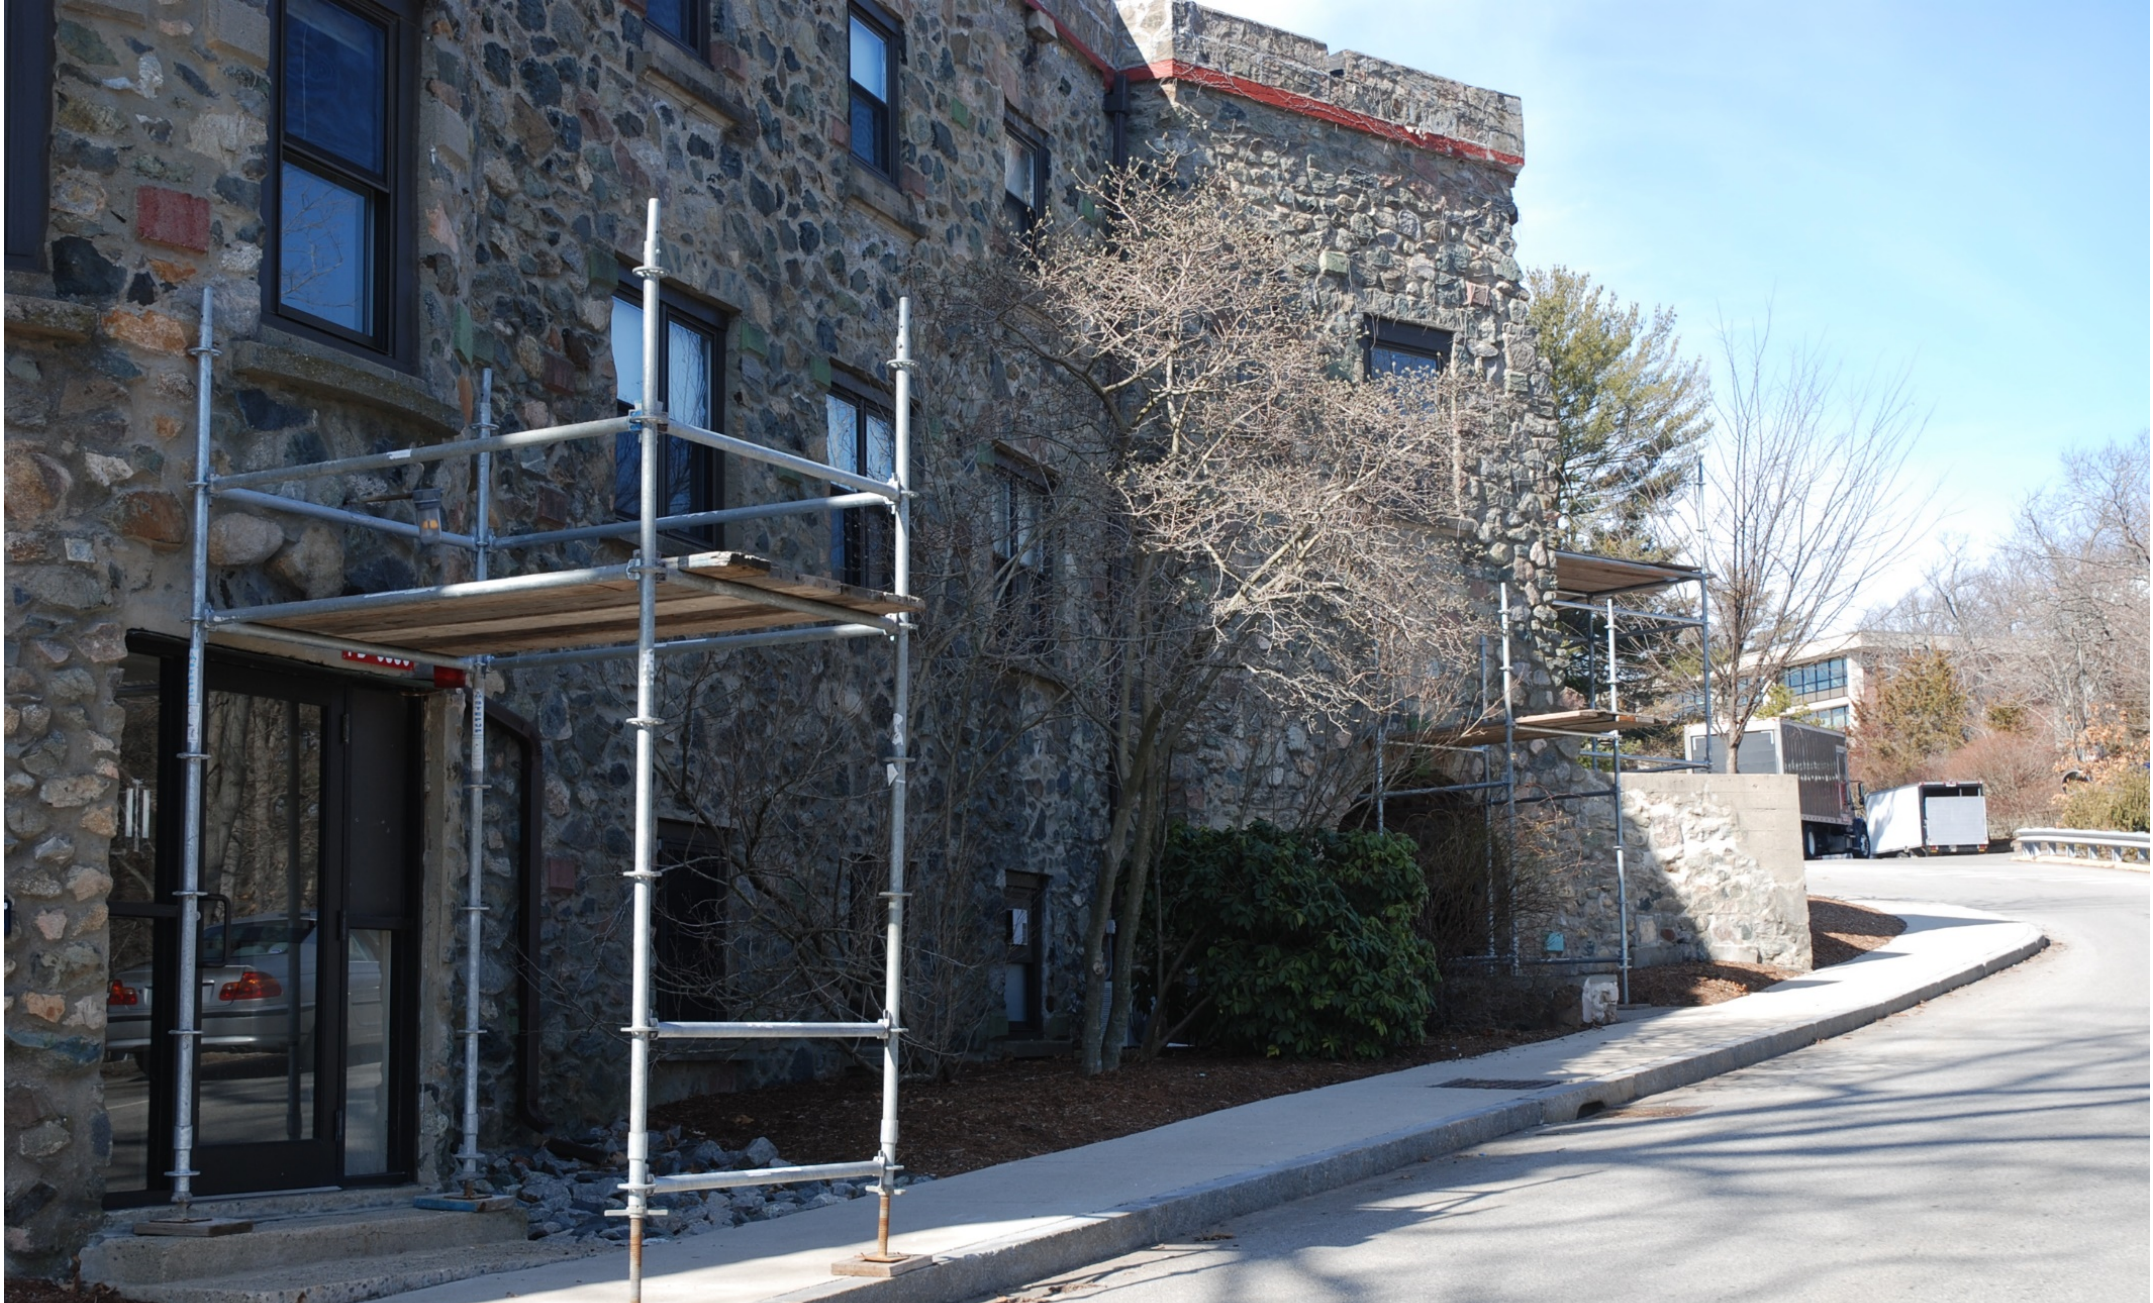
View of protective scaffolding at Schwartz Hall entries

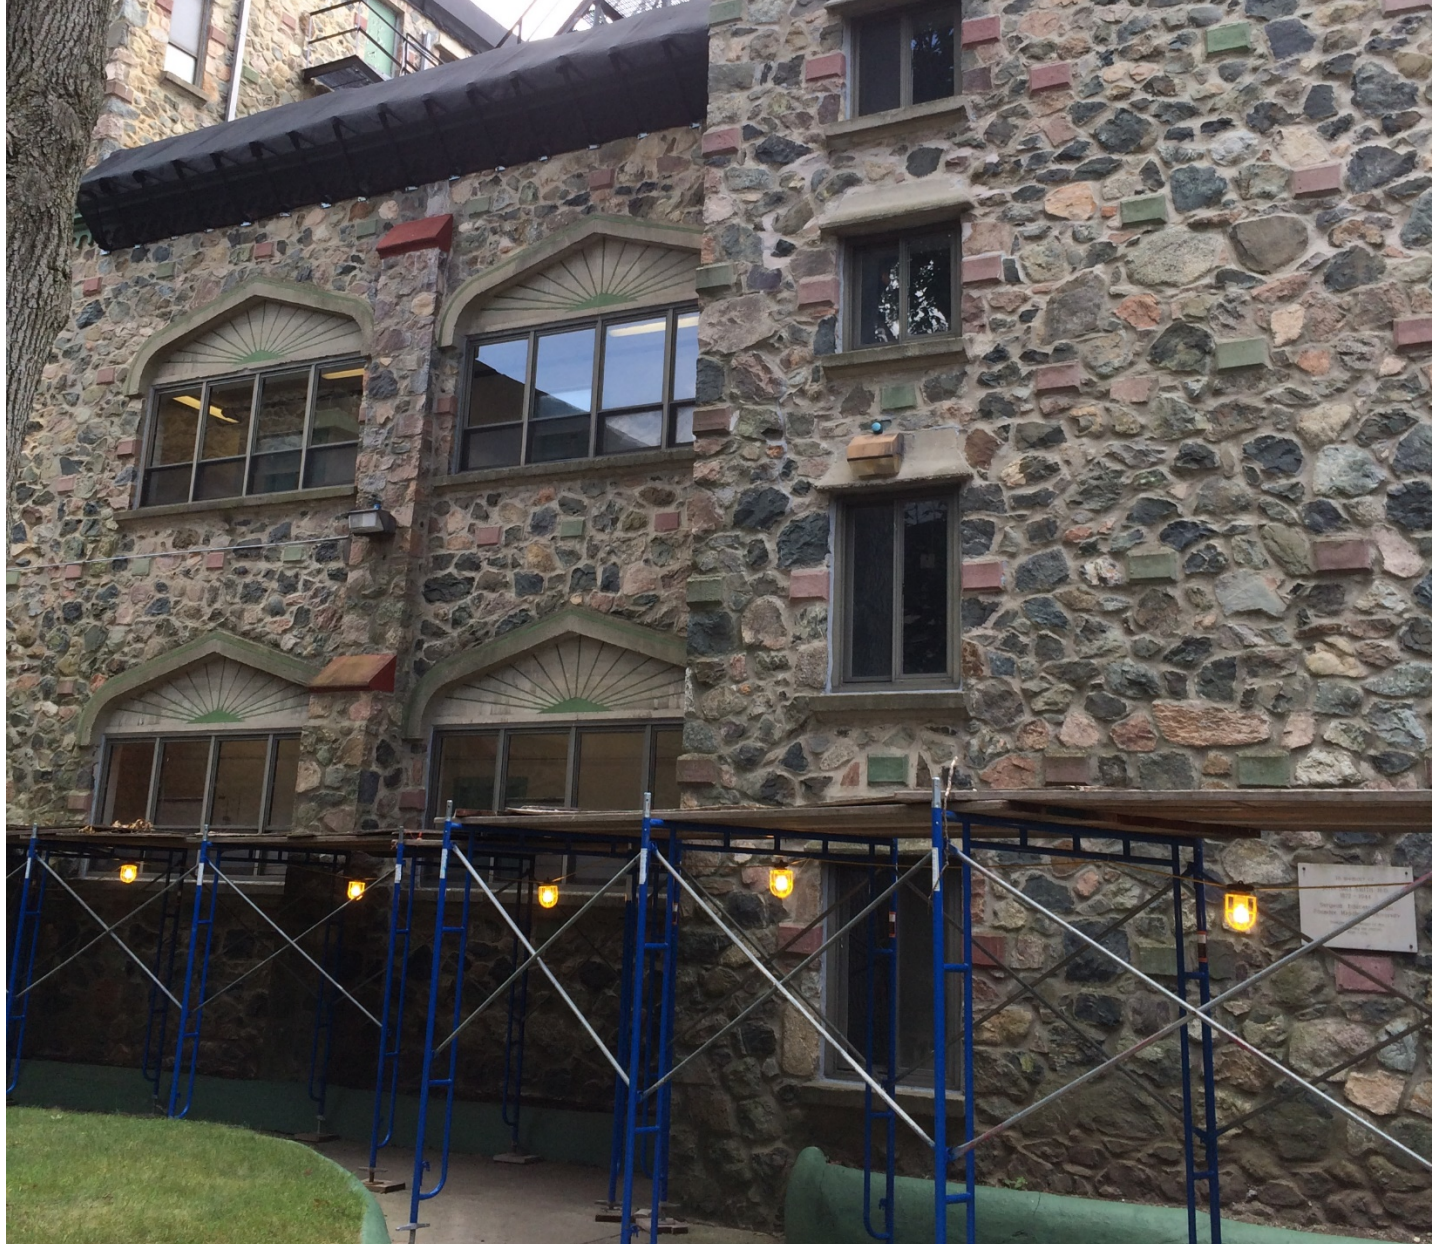
Slide #23

**View of protective scaffolding at
walkways leading to Tower A and
Tower B entries**

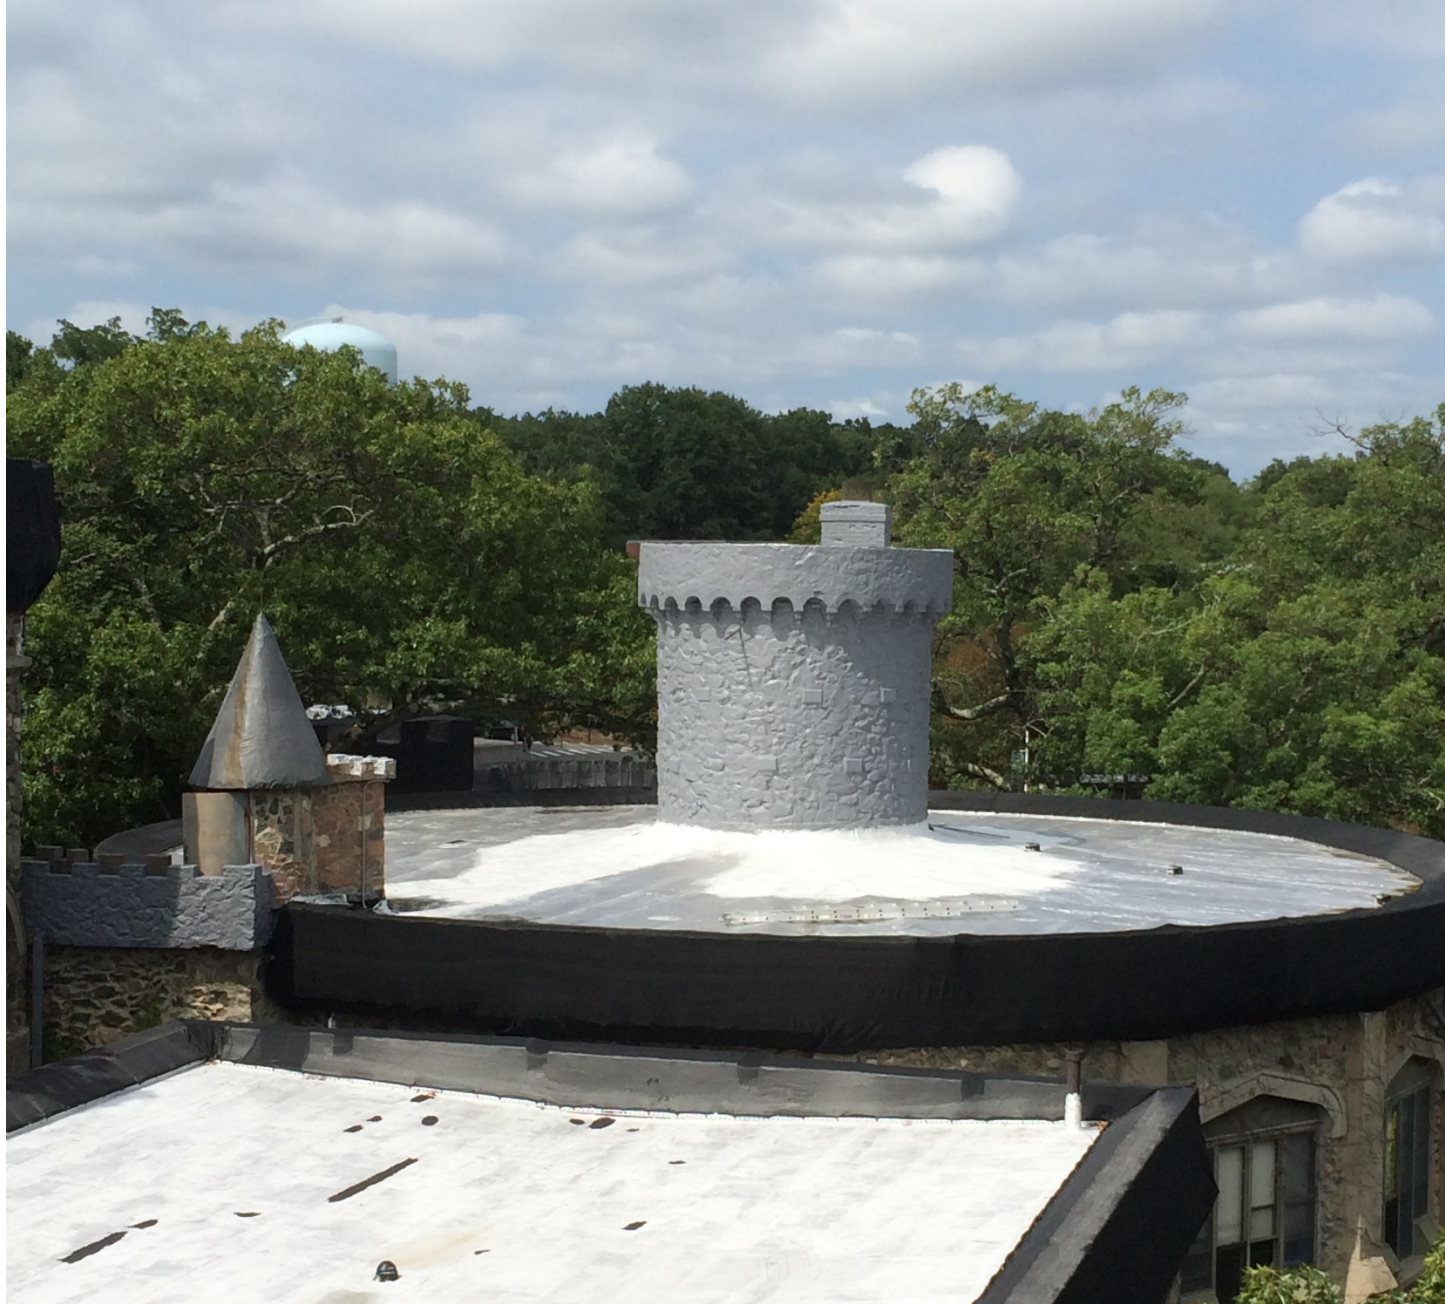
**View of the roofs at Tower C
and Tower D**

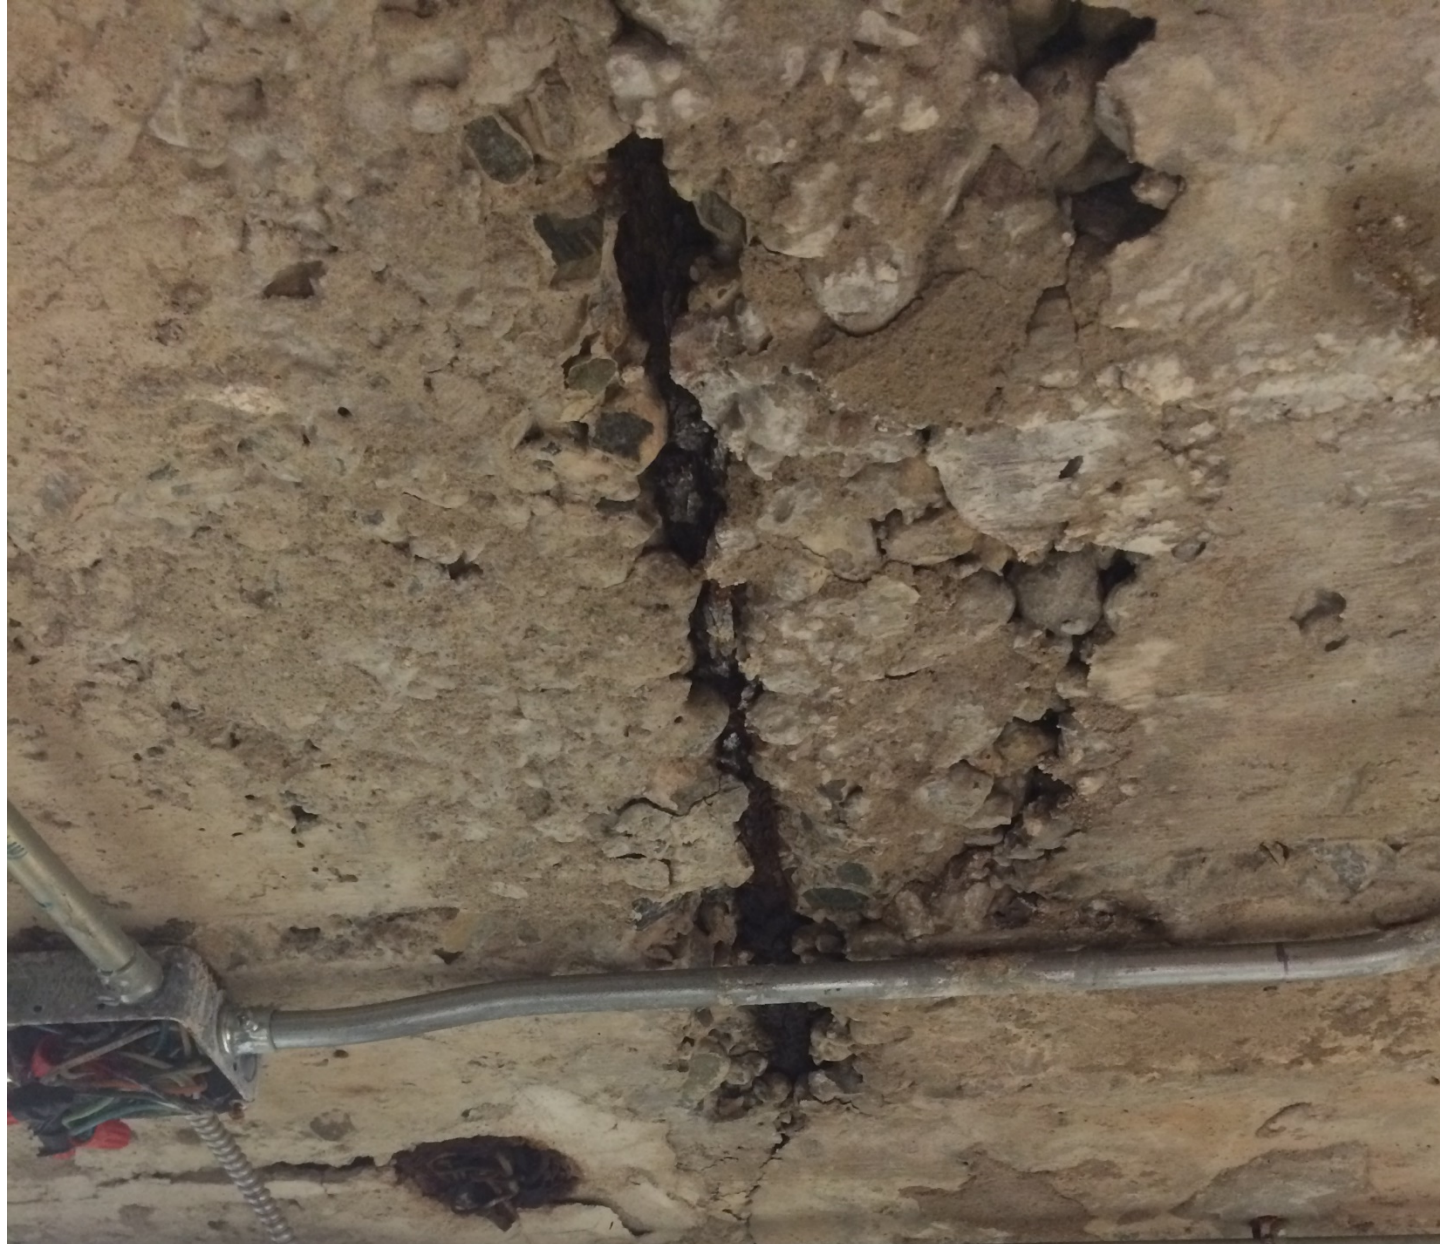
Slide #25

View of the cracks and voids in the underside of the concrete slab at Tower C entry.

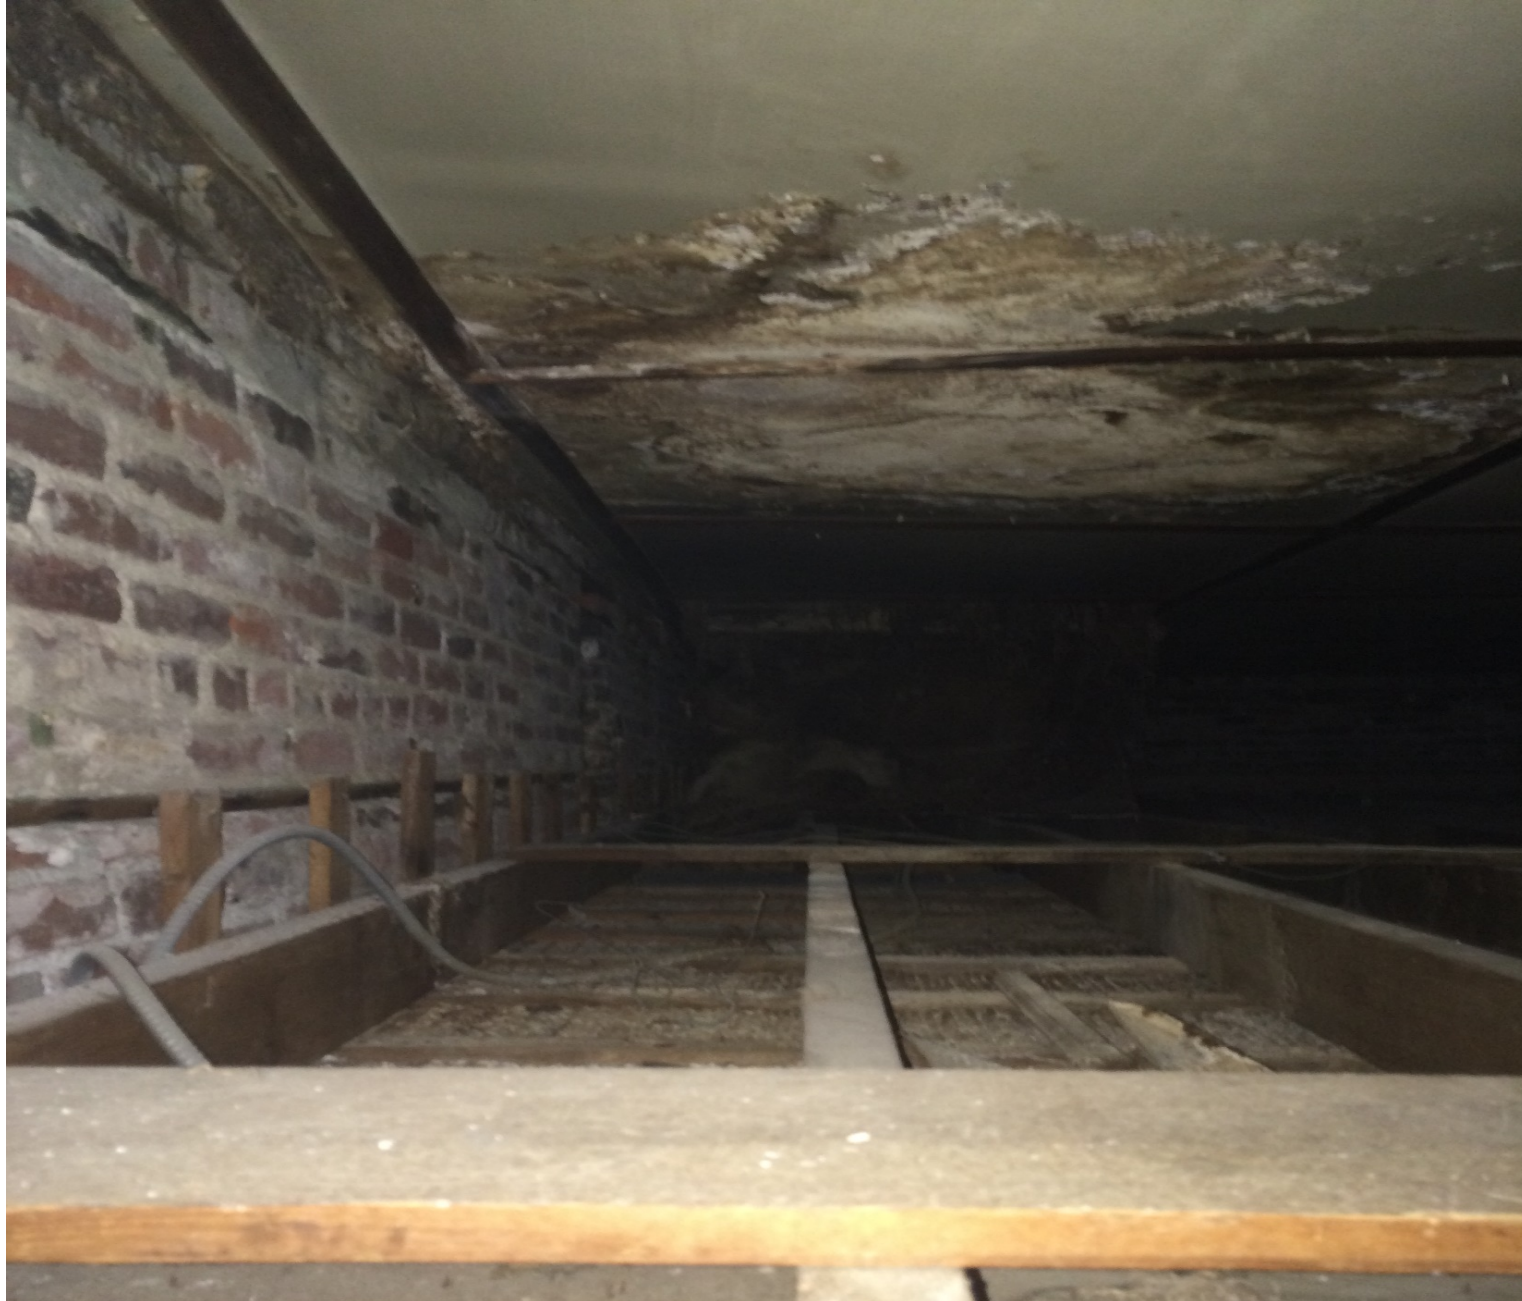
View of moisture staining in plaster ceiling in Tower A

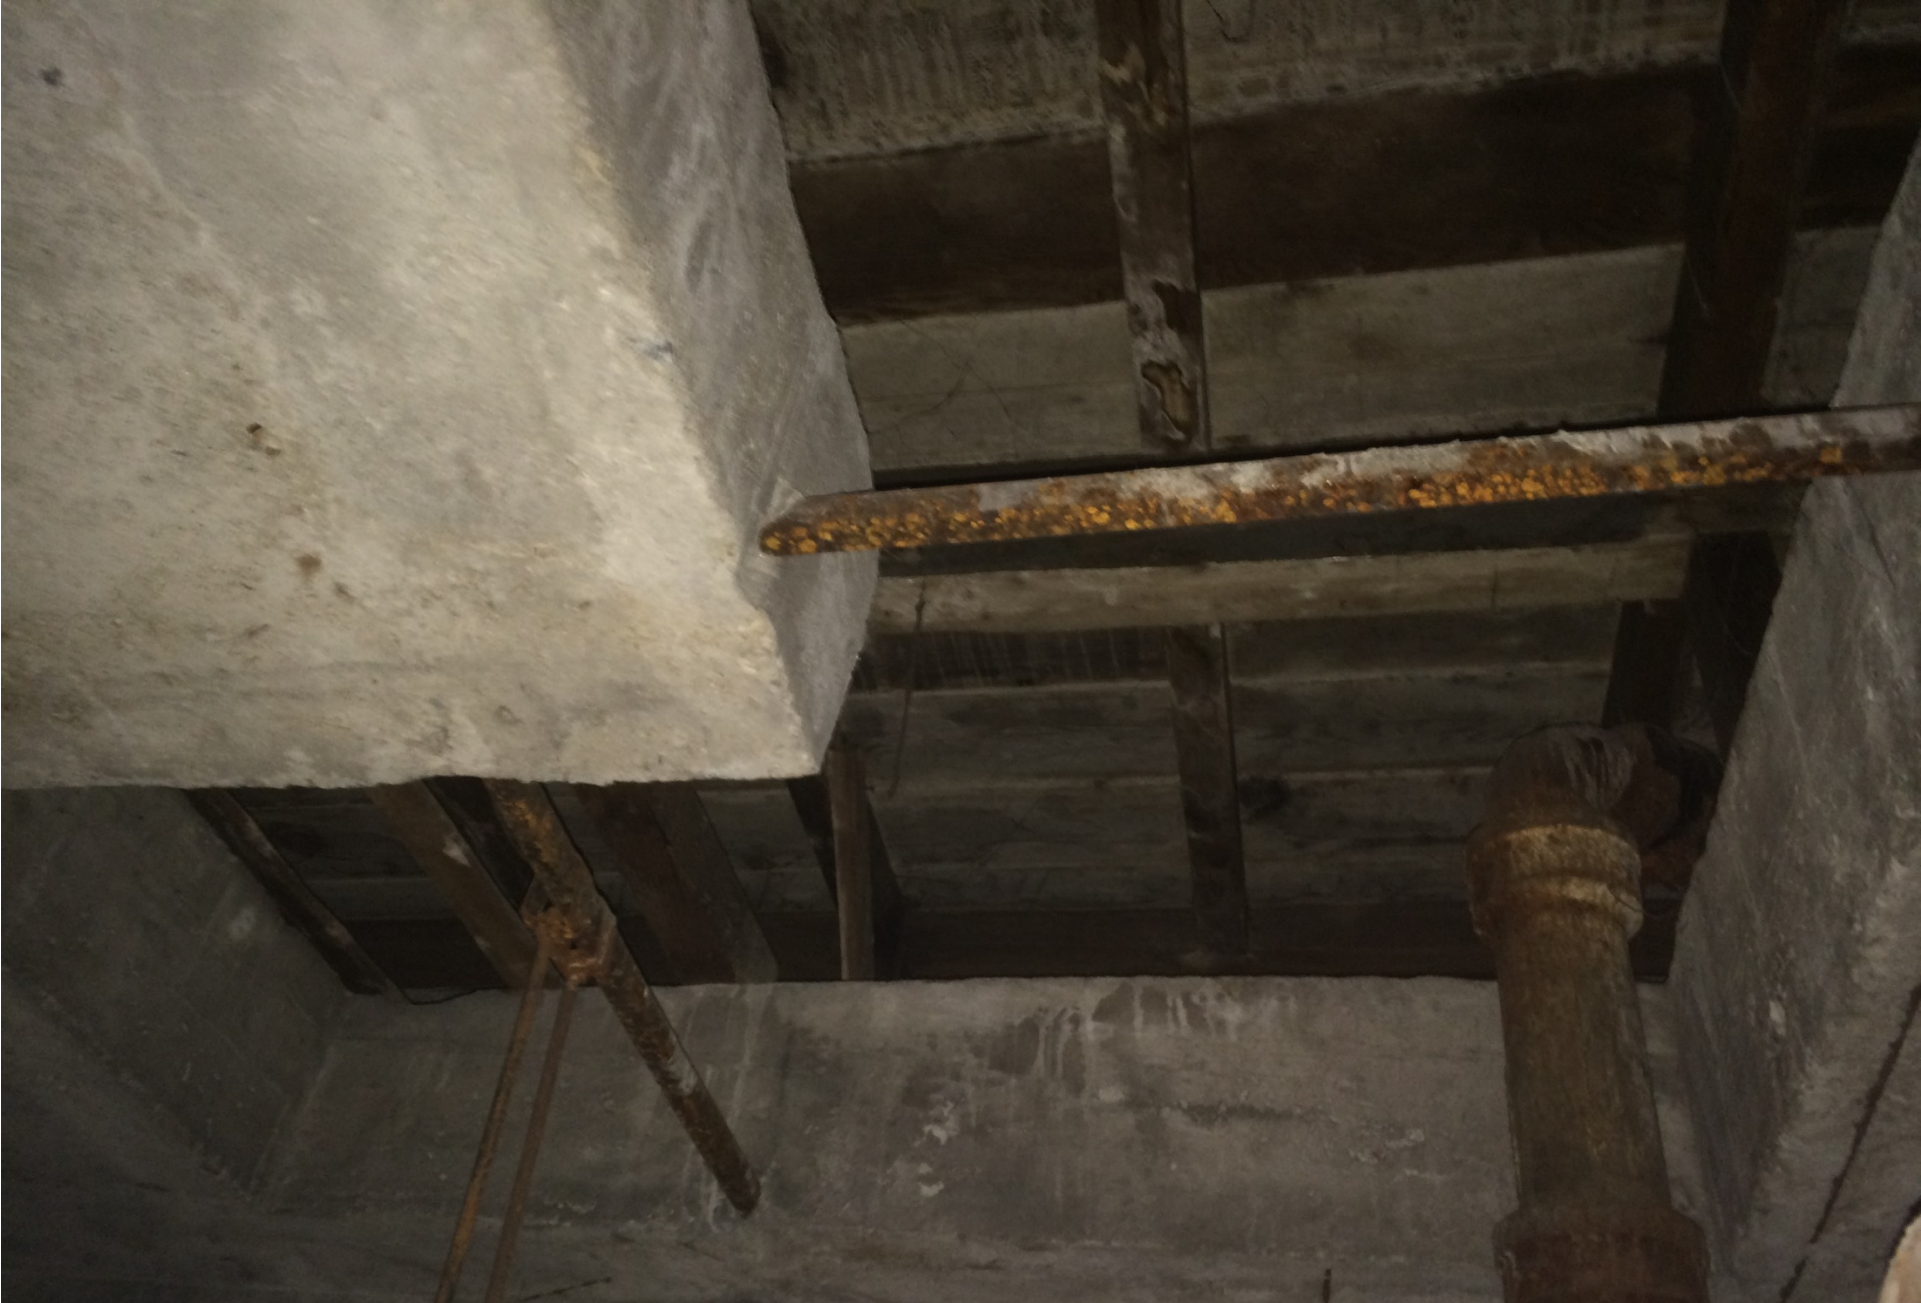
**View of moisture staining on wood structure
and corroded metal in Tower B**

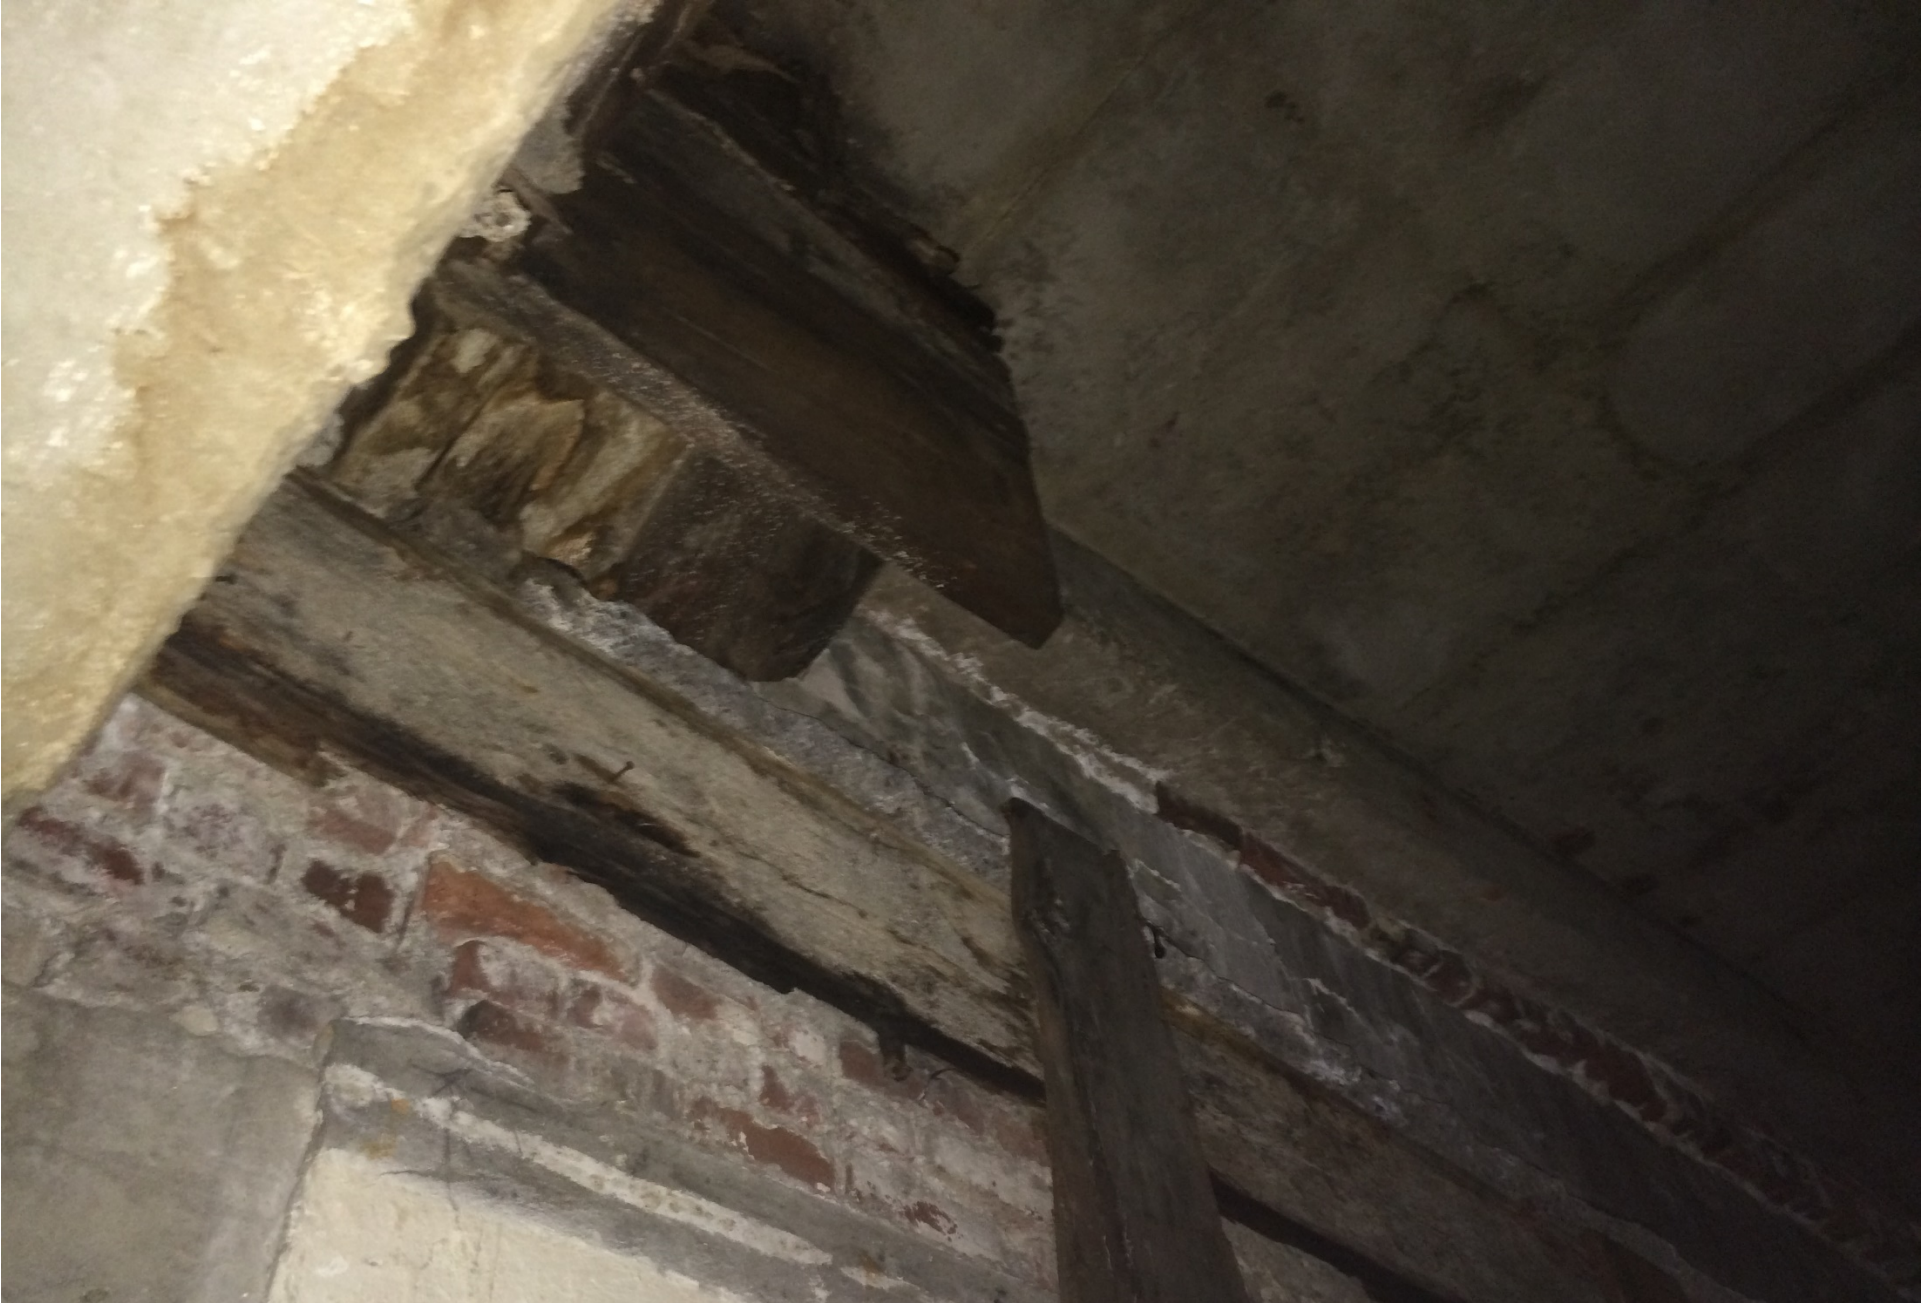
**View of moisture staining of wood structure
in Tower C**

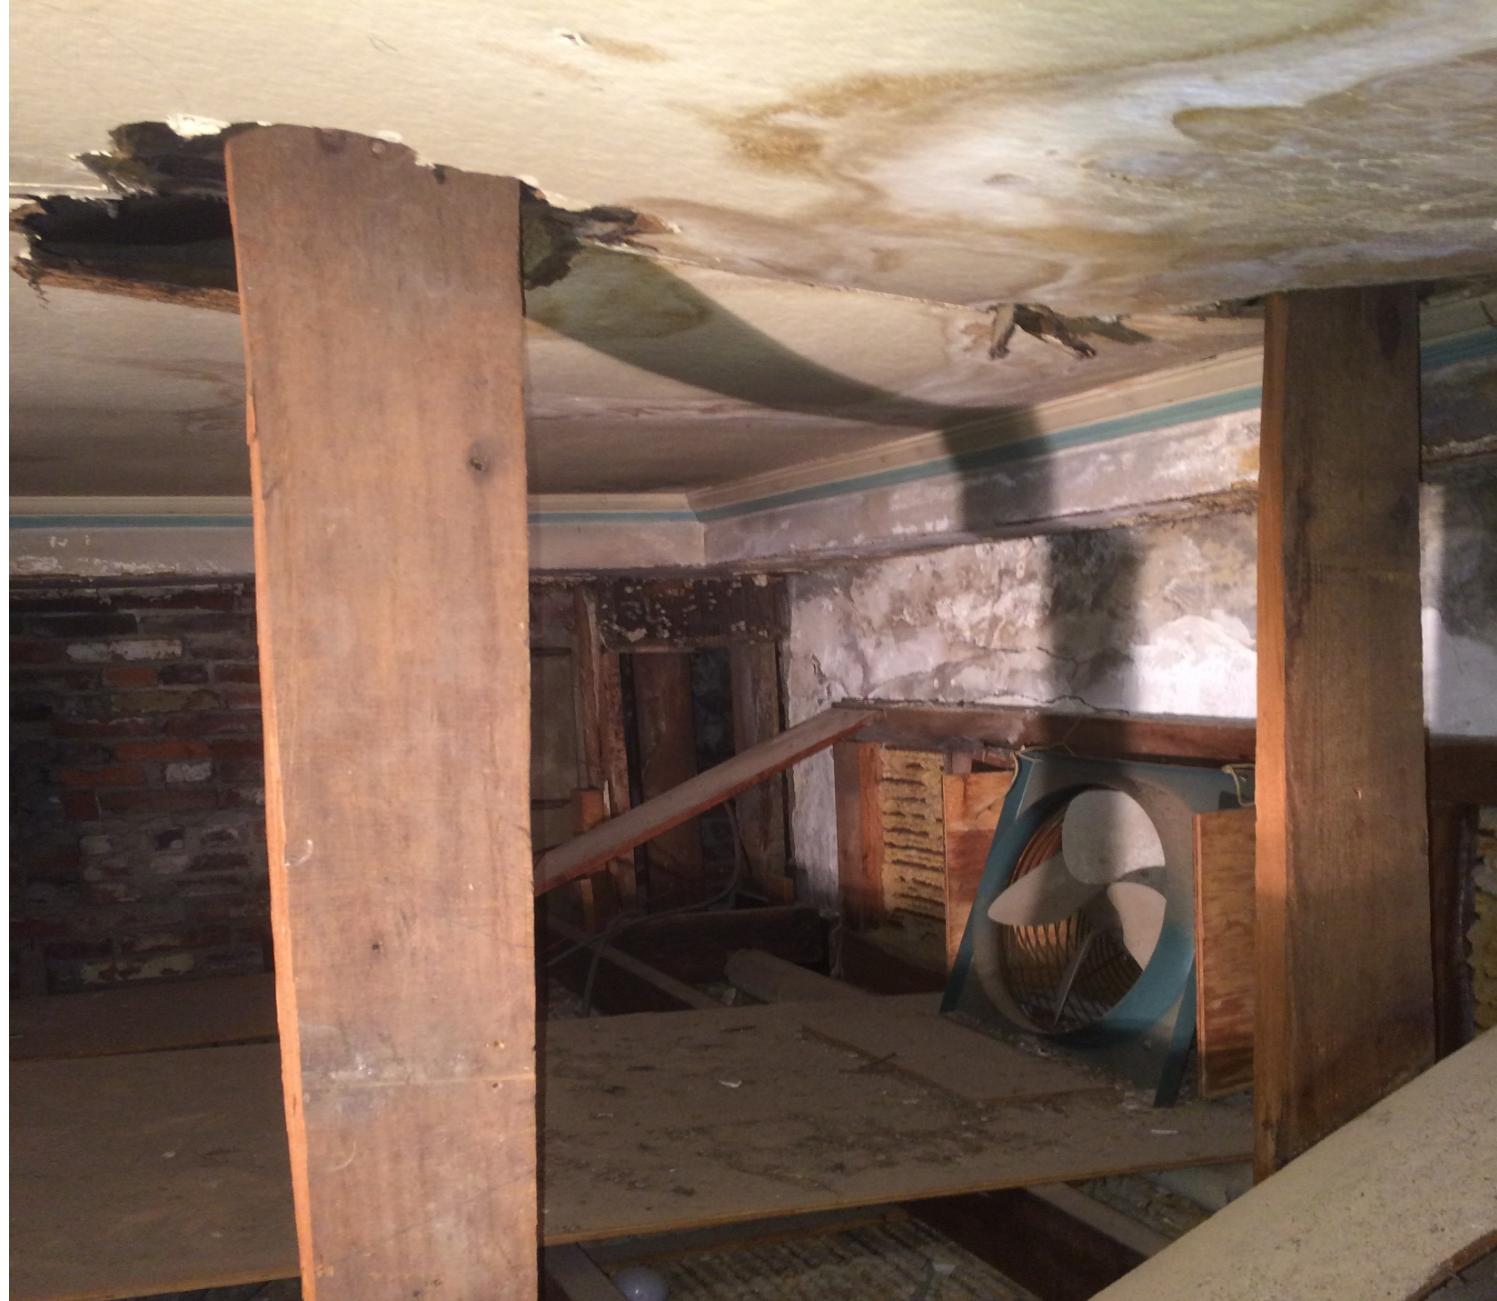
View of moisture staining on damaged plaster ceiling in Tower E

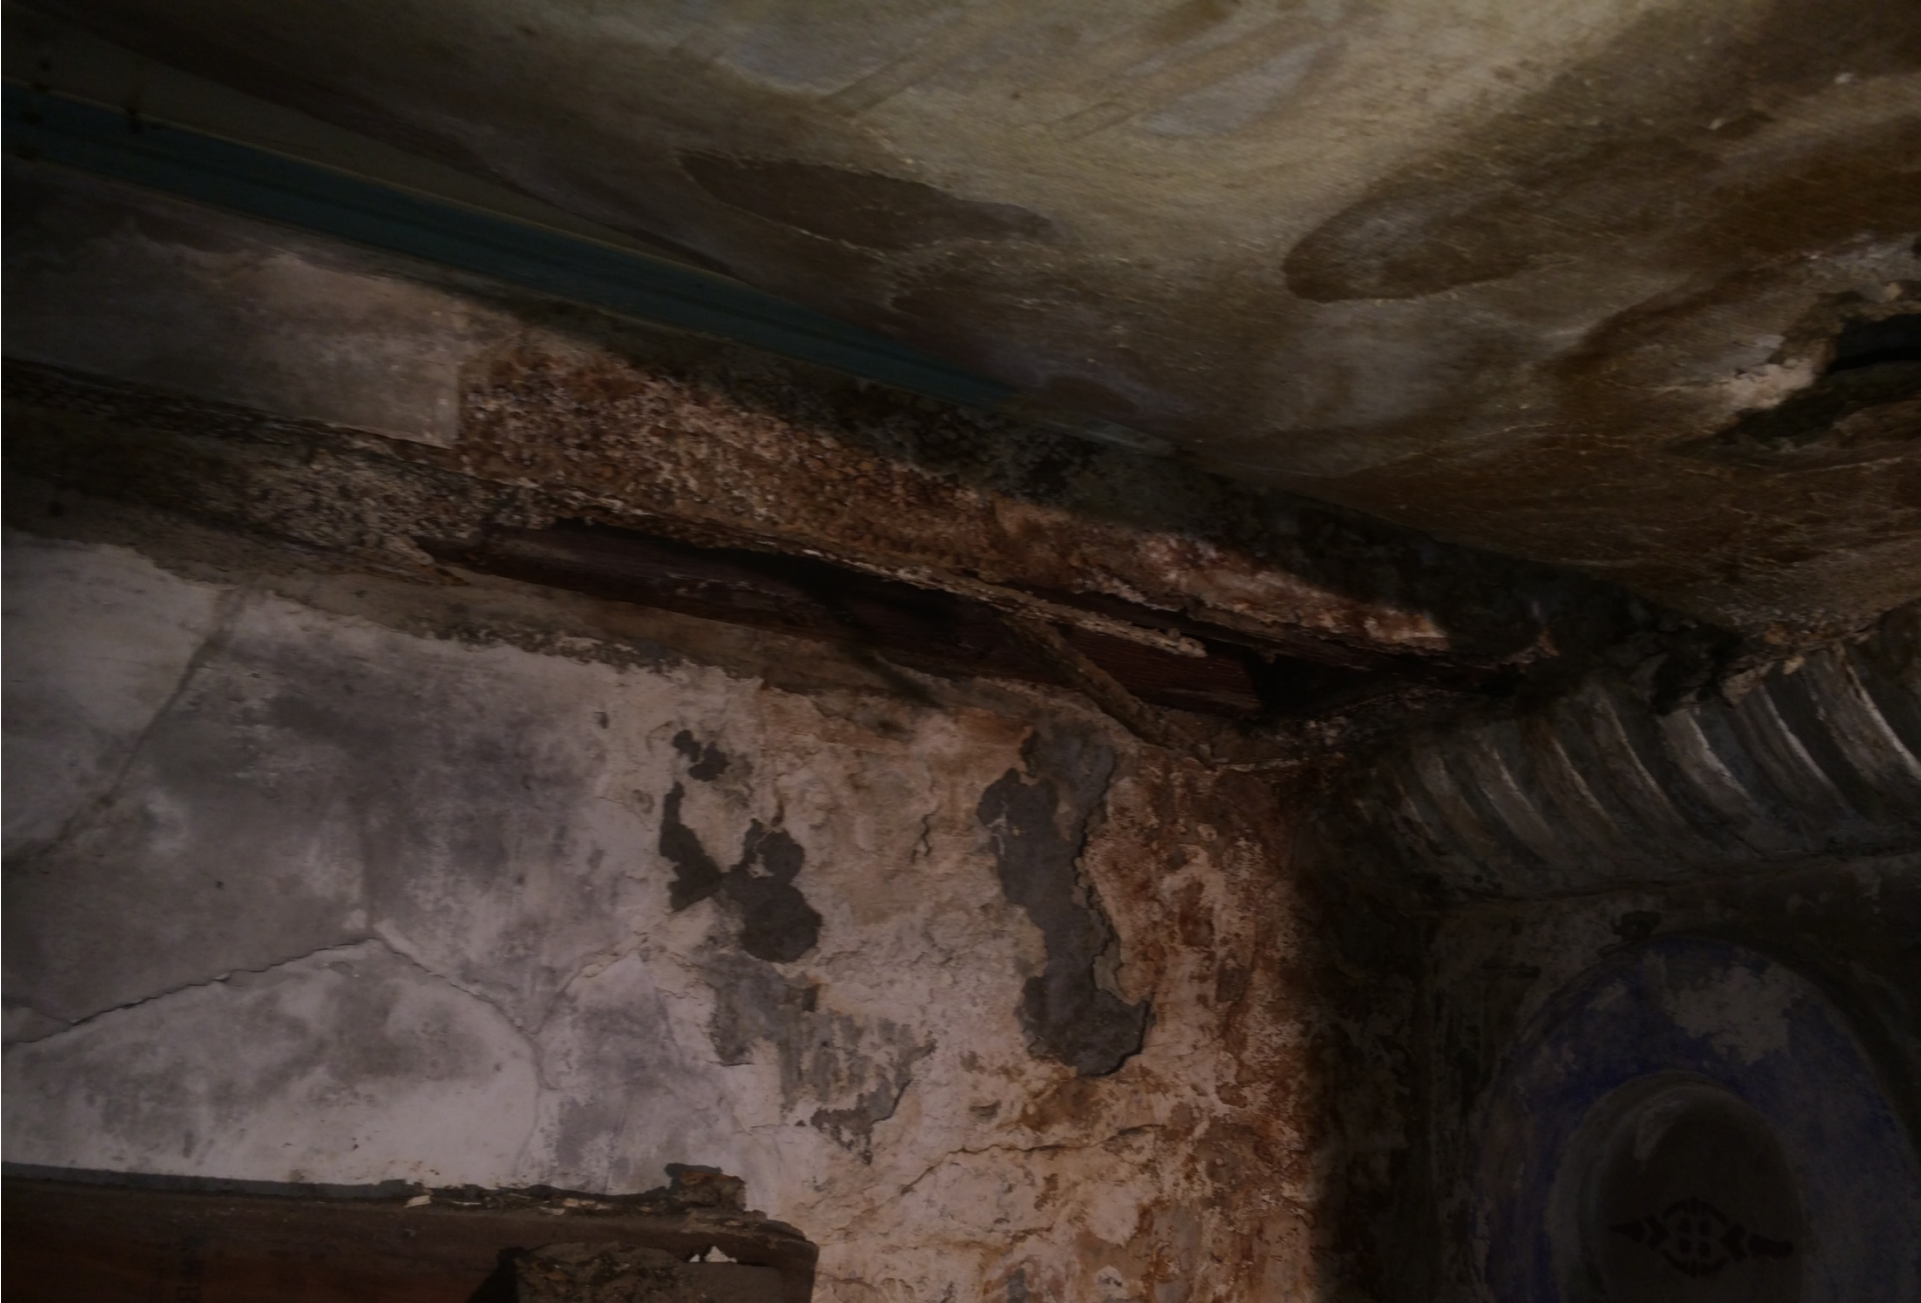
View of moisture damage on plaster and corroded metal structure in Tower A abandoned stairway

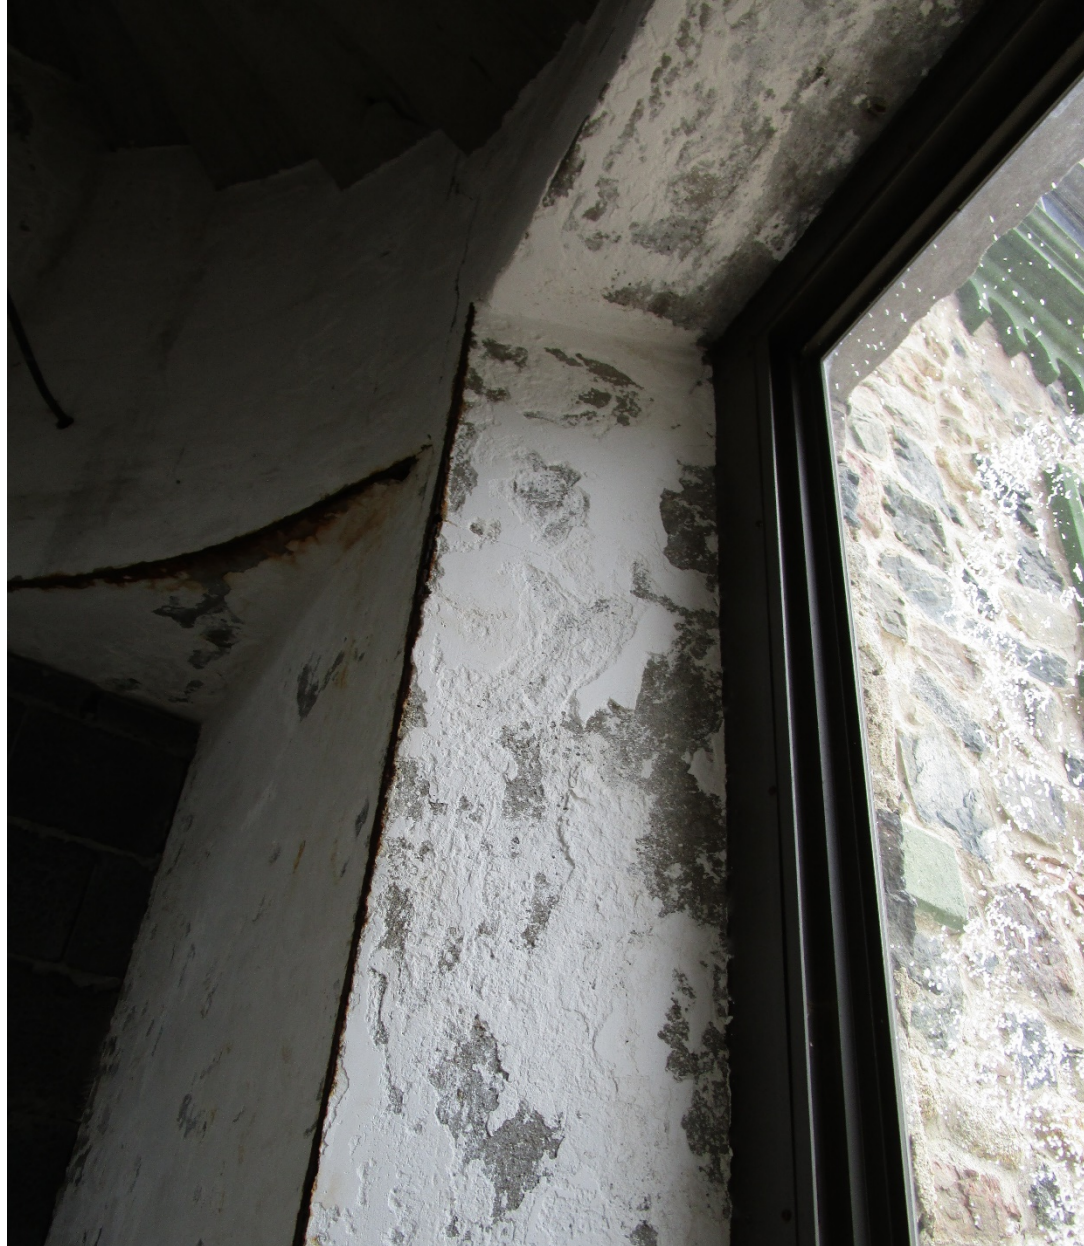
Slide #31

View of plaster damage and corrosion at Tower A abandoned stairway
