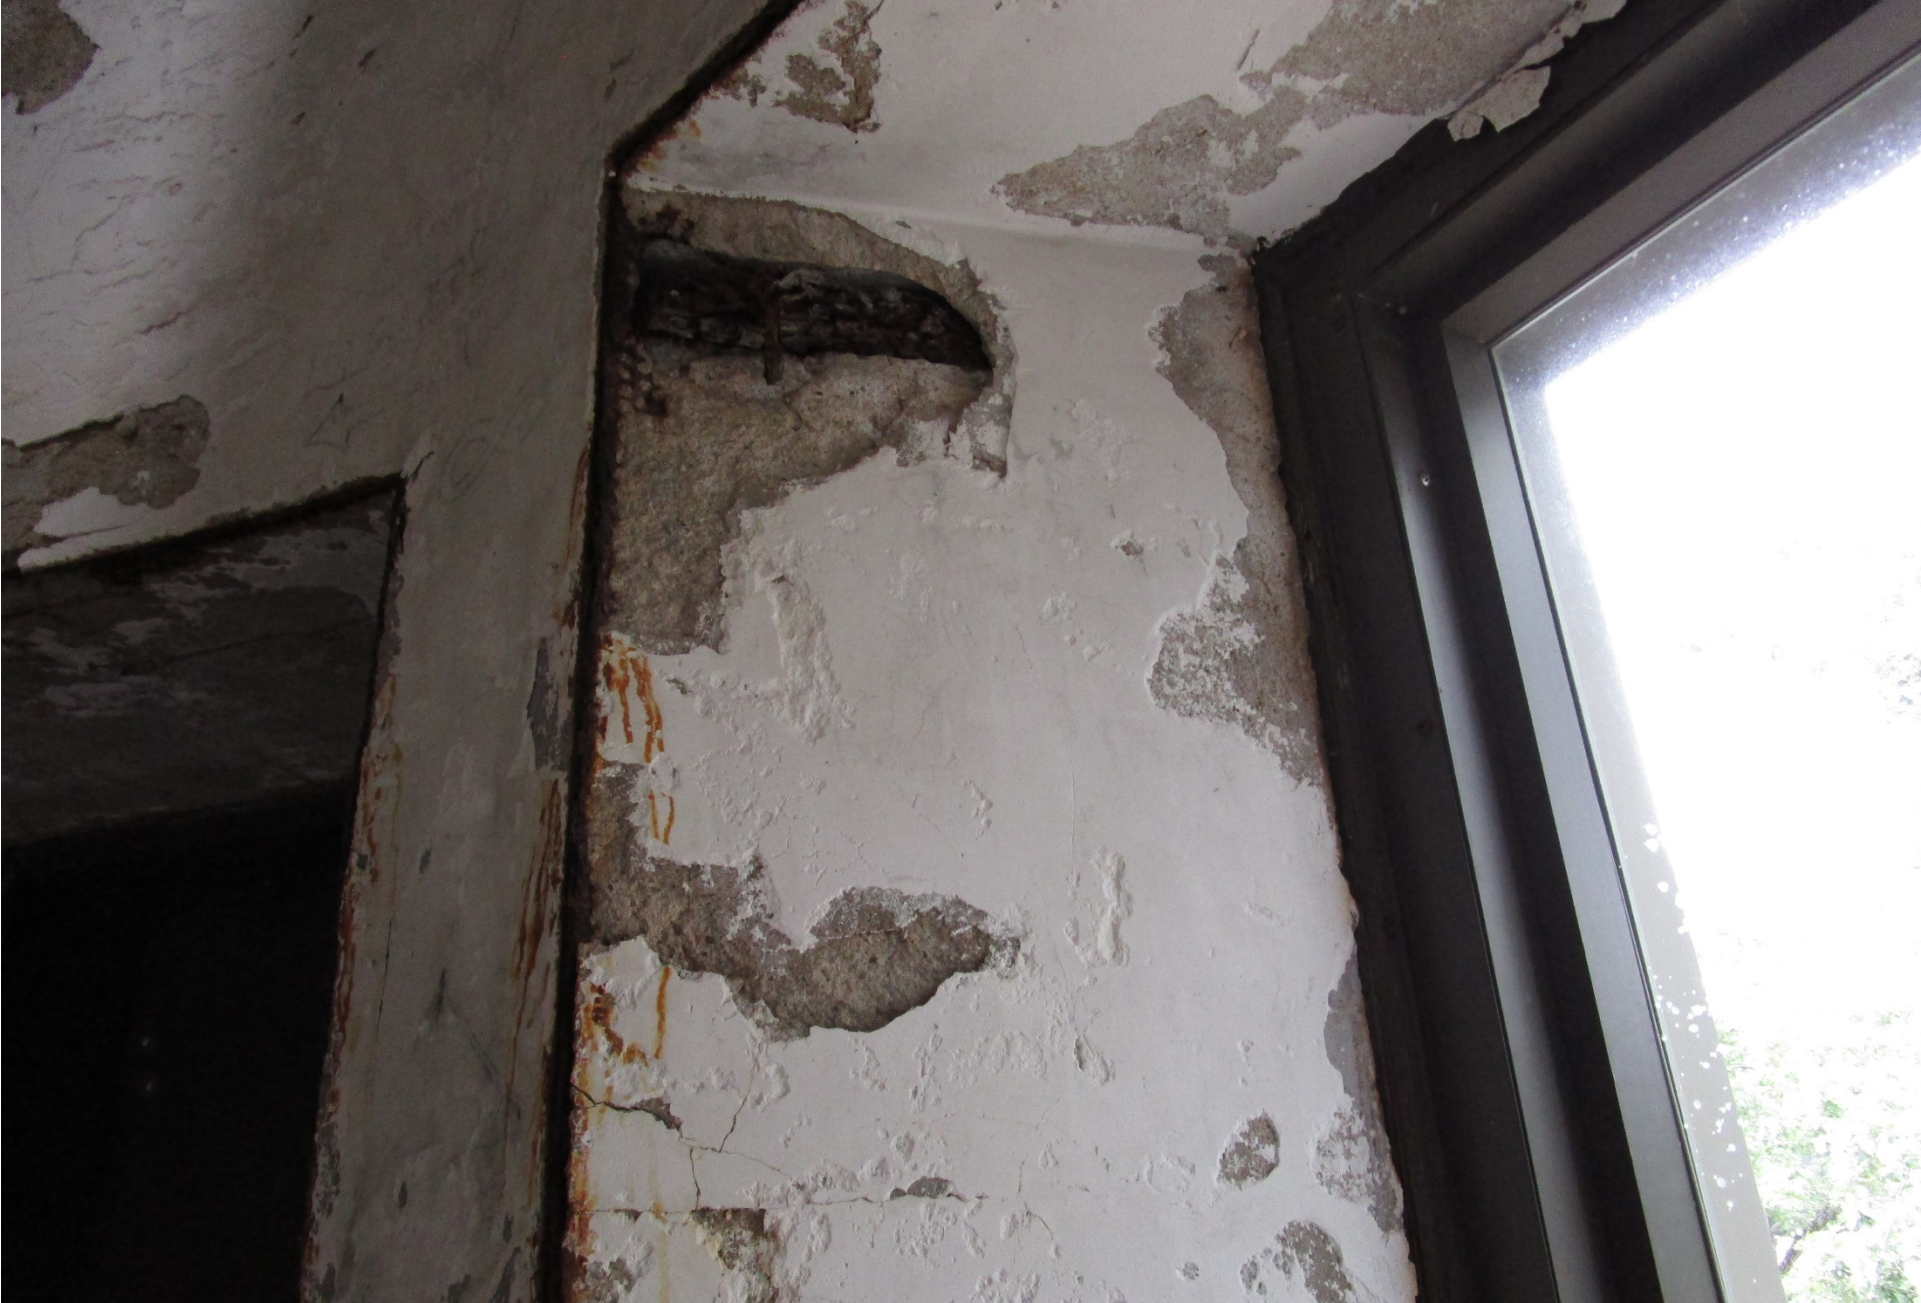
**View of plaster damage and corrosion at
Tower A abandoned stairway**

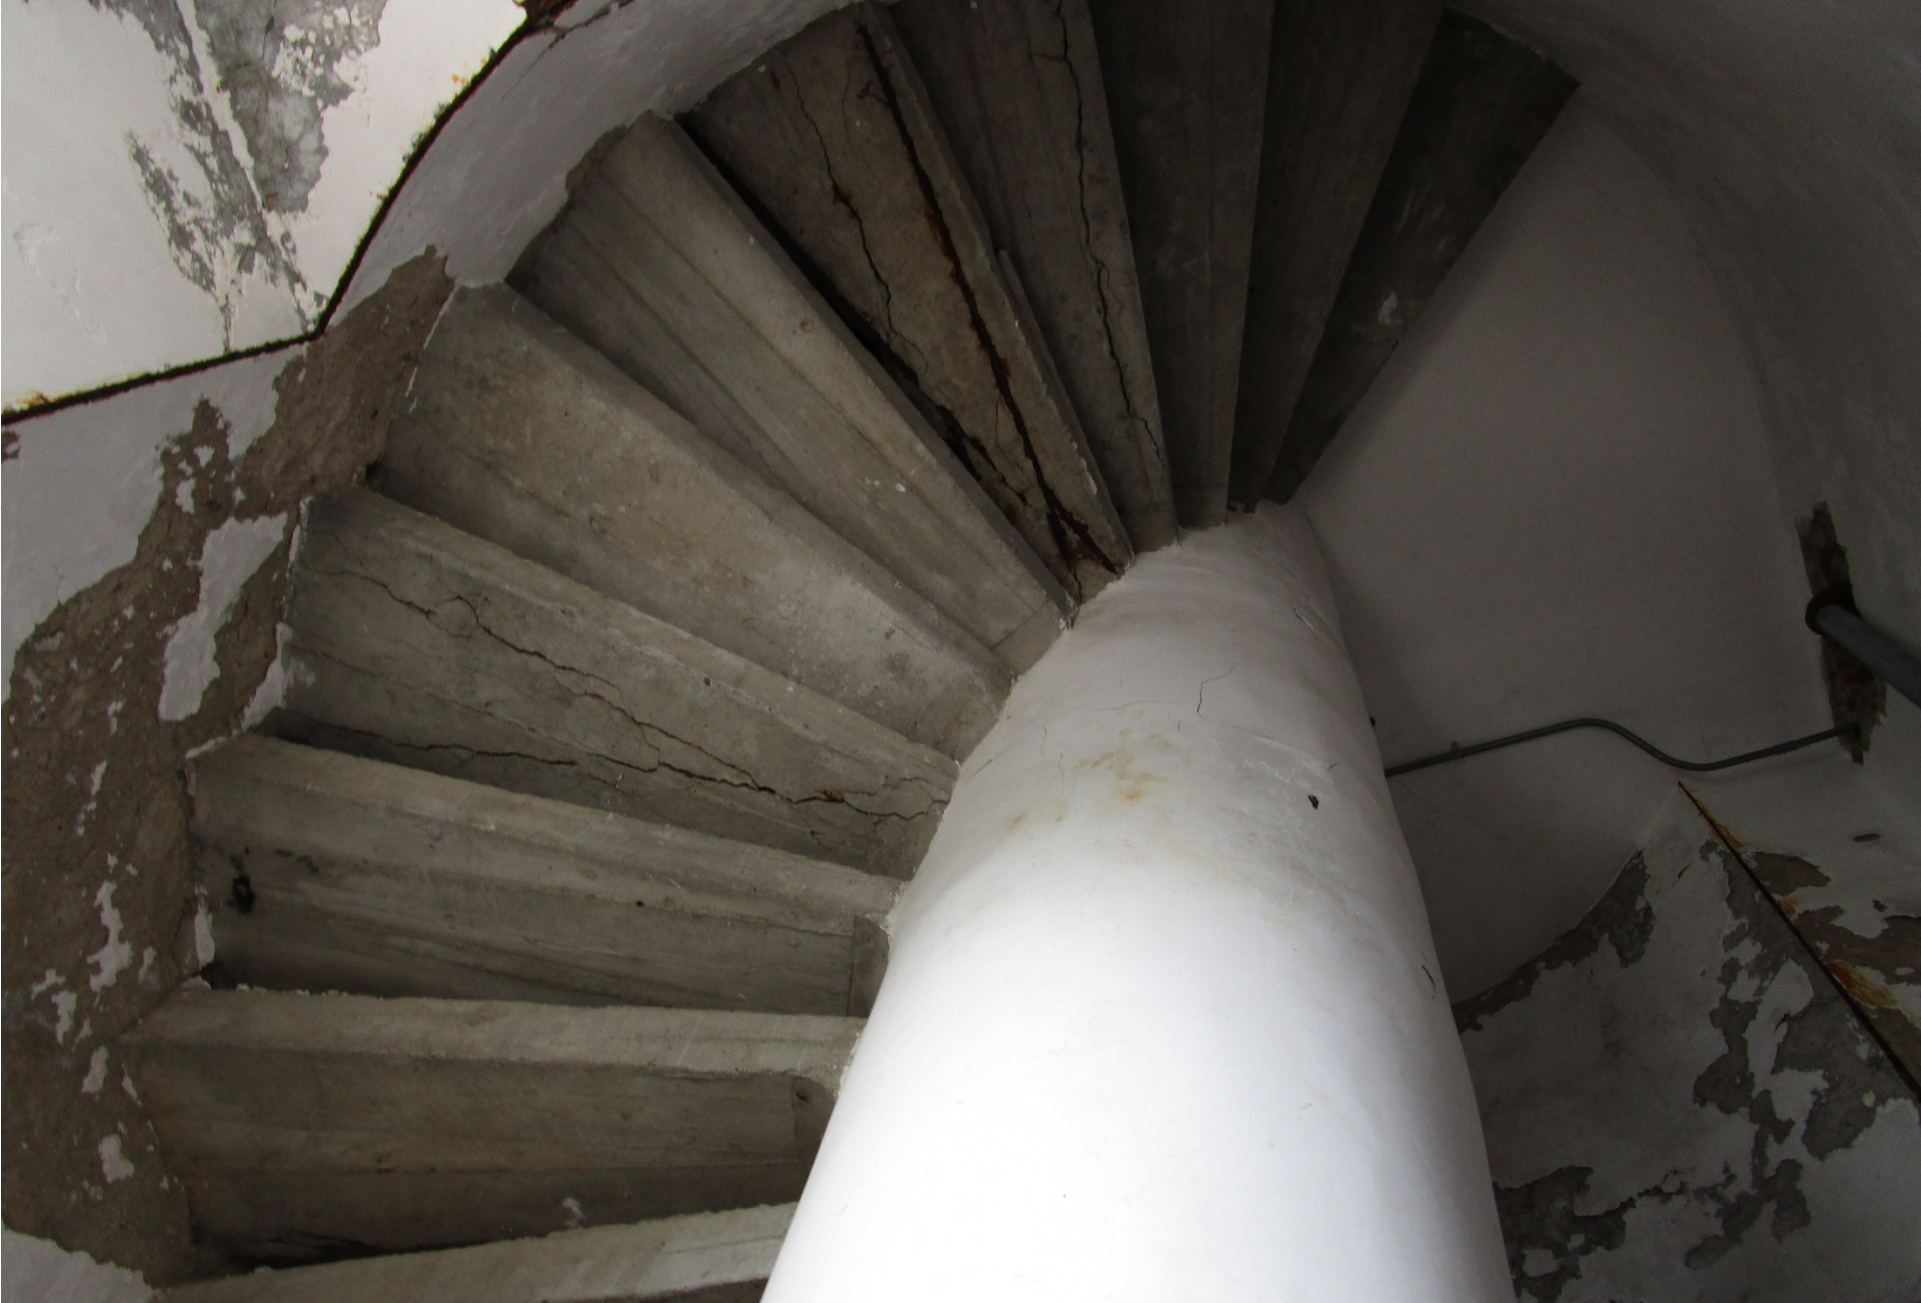
View of the cracked concrete and exposed reinforcing at Tower A abandoned stair
